## KB STARTING MOTORS

Thermoplastic-encapsulated terminals      ST 0438 En

ELECTRICAL  
CONNECTIONS

# N3 ALTERNATOR

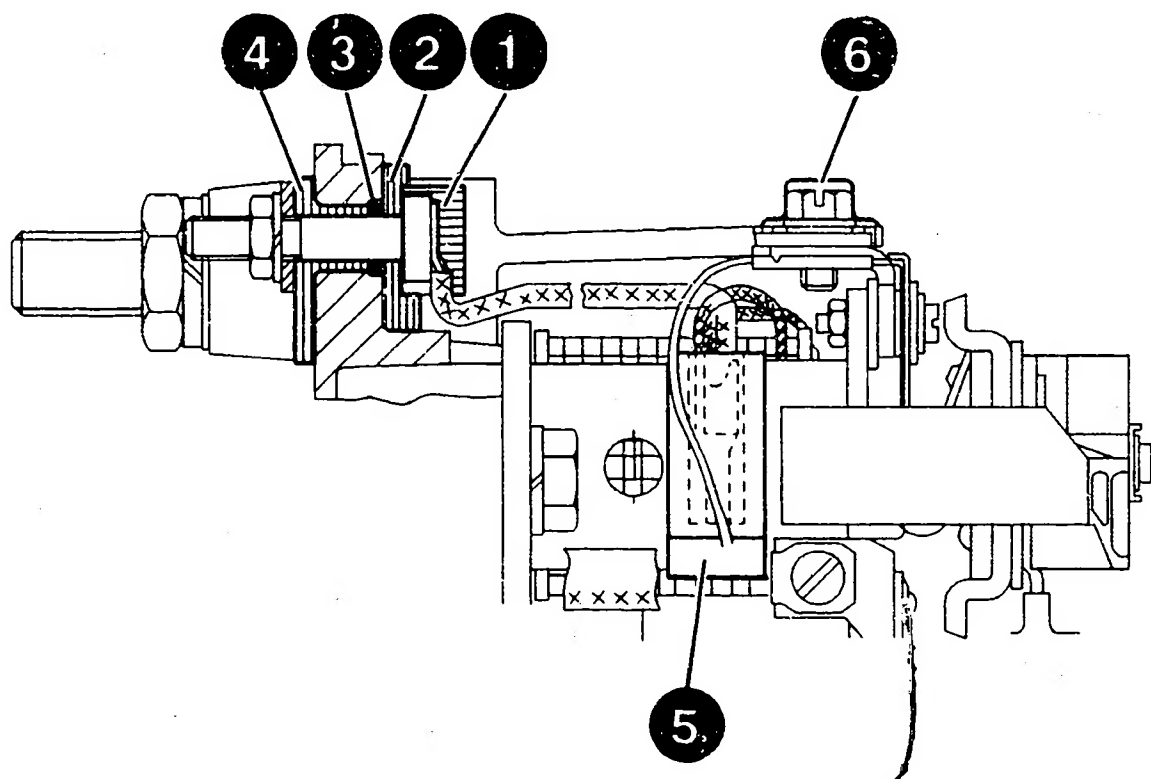
Fig. shows new insulated version:

- 1 = Insulated terminal stud term. 50
- 2 = Insulating part term. 30,  
term. 50 inner
- 3 = O-ring
- 4 = Insulating part term. 30,  
term. 31 and term. 50 outer
- 5 = Retainer (disposable item)
- 6 = Insulating cap term. 30

The new insulated version of term. 30 is shown at the bottom of the fig.

- 1 = Insulated connecting bar term. 30
- 2 = Seal term. 30 (red)
- 3 = Insulating part term. 30, term. 50 inner
- 4 = O-ring
- 5 = Insulating part term. 30, term. 31 and term. 50 outer
- 6 = Insulating cap term. 30

Following installation of new connecting bar term. 30 new insulating cap (6) must be fitted on hexagon bolt (term. 30).

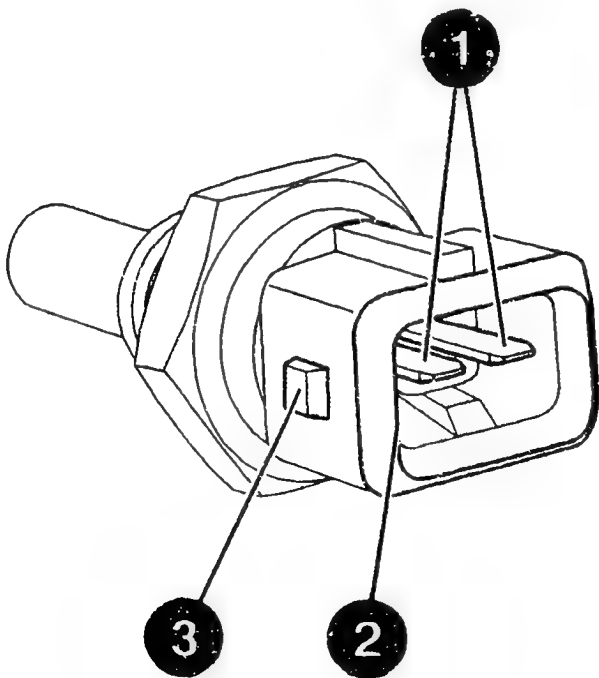
KKE01062

- Plug pins (1)
- End sealing edge (2)
- Side locking lugs (3)  
for spring clip

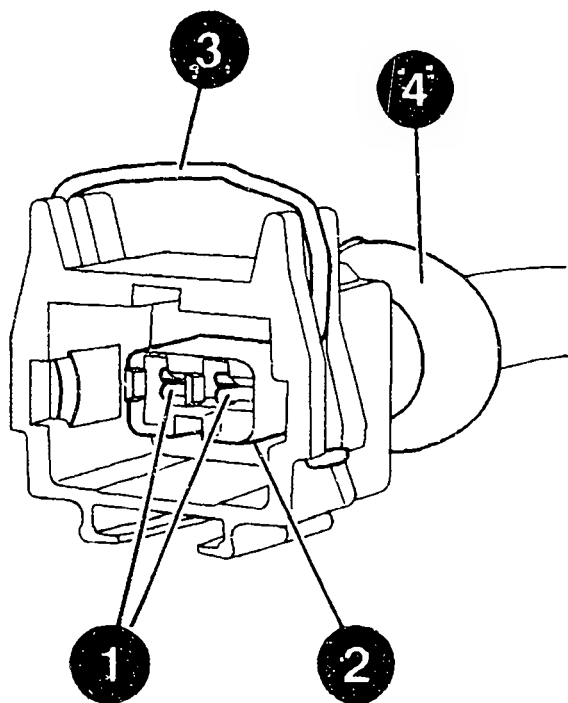
KKE01063

**Assessment of wiring-harness plug**  
**Note the following (see Fig.):**

- Flat spring contacts (1)
- End sealing ring (2)
- Spring clip (3)
- Protective cap (4)

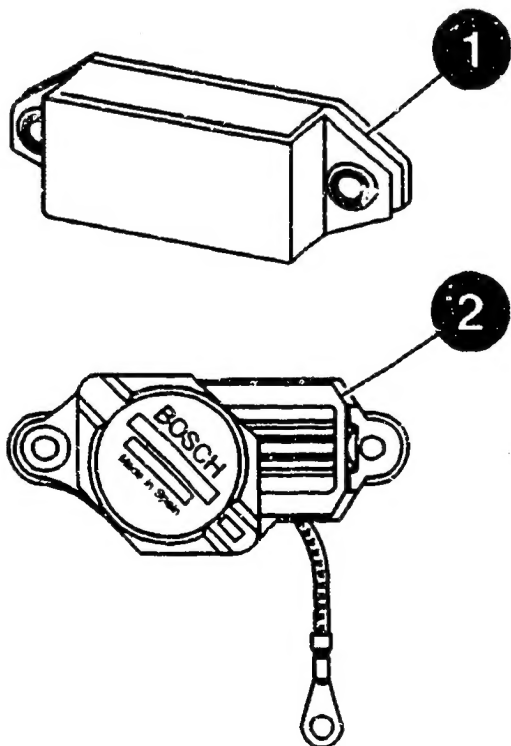
KME00322

For N3 alternators (0 122 469 00.) the EE regulator 0 192 053 010 was replaced as of 03.95 (FD 563) by the new EL regulator 1 197 311 318.

- 1 = EE regulator 0 192 053 010
- 2 = EL regulator 1 197 311 318

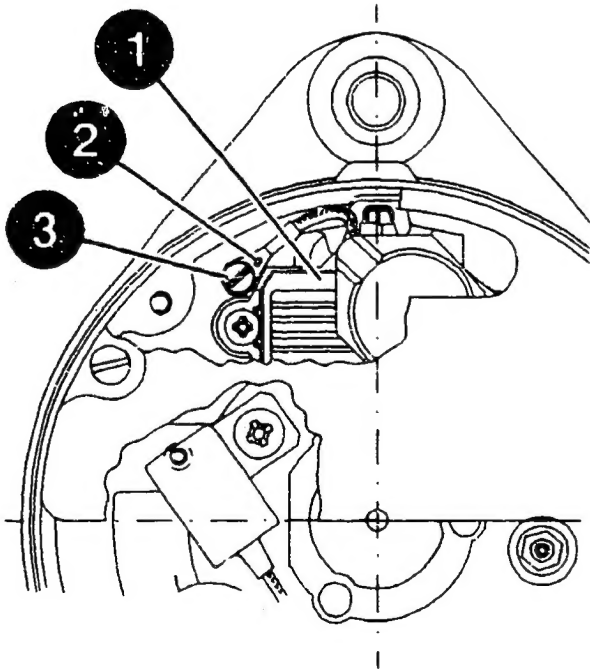
KME00323

- 1 = EL regulator
- 2 = Ground connection with terminal
- 3 = Stud M4

The additional ground connection (D-) of the EL regulator must be attached to ground with an M4 stud.
